Neil Trenwith Director Magnatex Industries

What is it

Case Studies

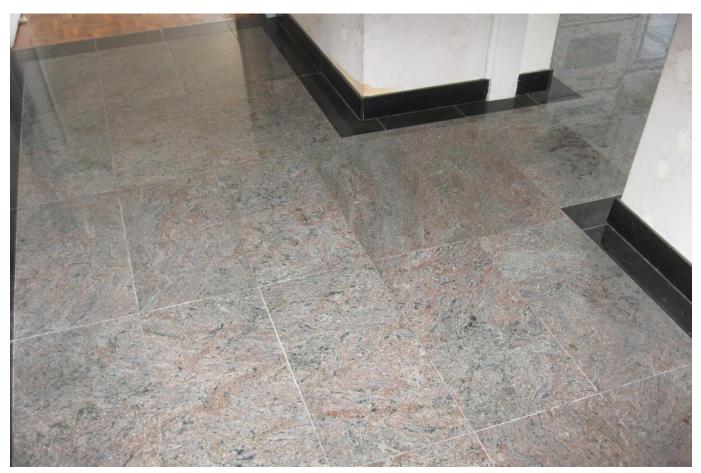
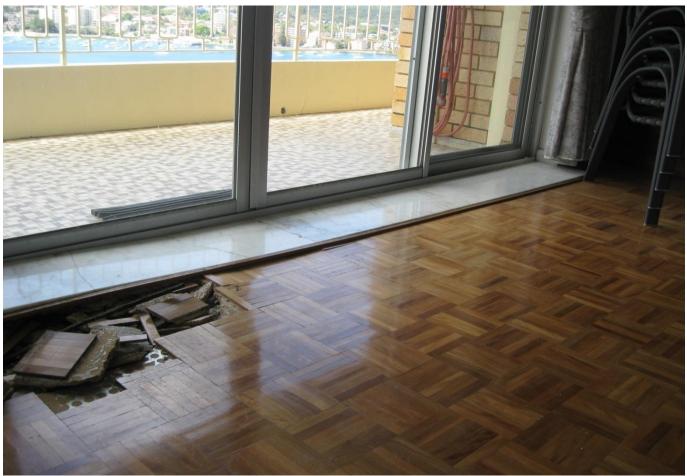
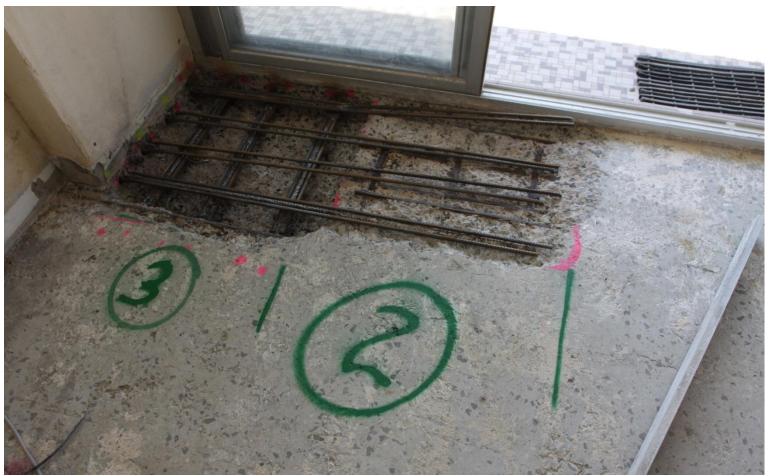
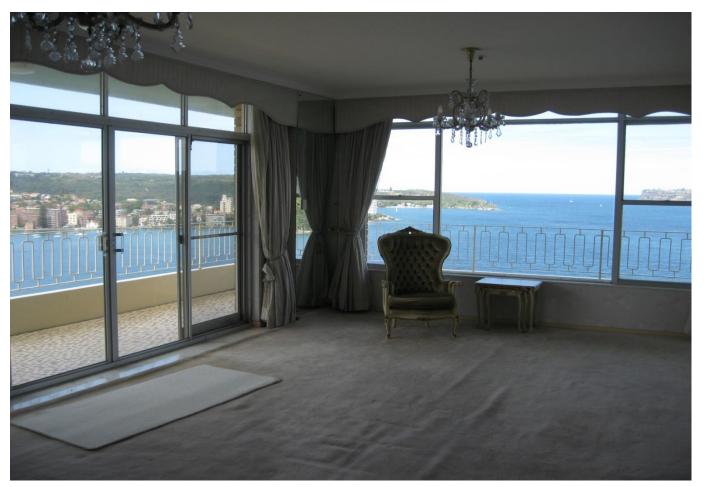
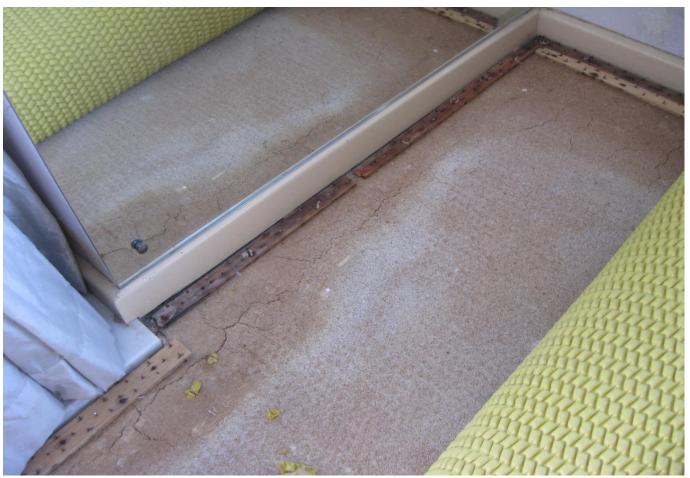
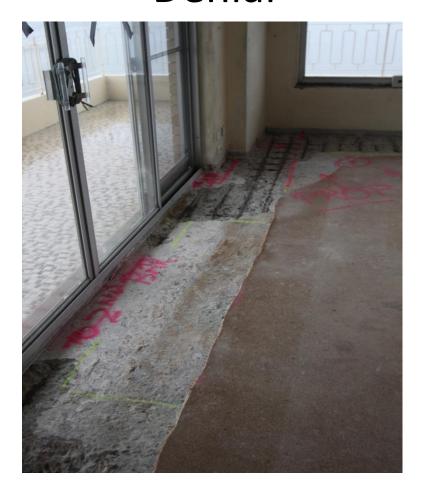
External degradation

- Cause
 - ingress of moisture
 - windows
 - doors
 - flashings
- EC reluctant to acknowledge damage
- Early intervention, appropriate repair strategy and treatment result in minimal expenditure

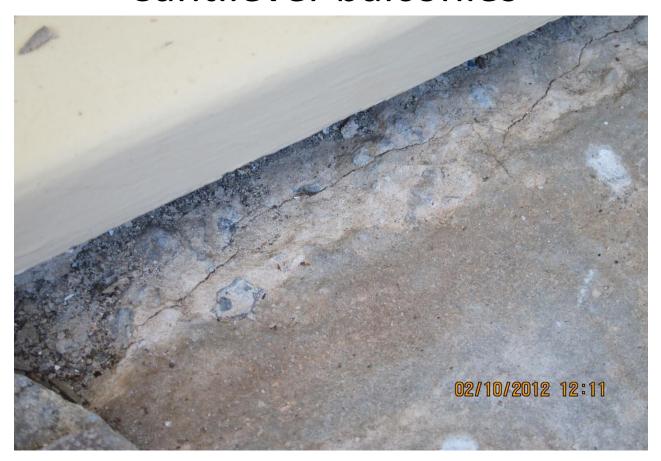
Cantilever balconies

- Cause
 - Magnesite
 - Ingress of moisture
 - Leaking windows
 - Lack of cover
 - Poor quality concrete
 - Poor design poor implementation
- Early intervention will result in major cost savings
